Strong Rail-Post Connections for Wooden Decks

Where common connection details fail to meet code loads, prefab galvanized hold-down hardware passes the test

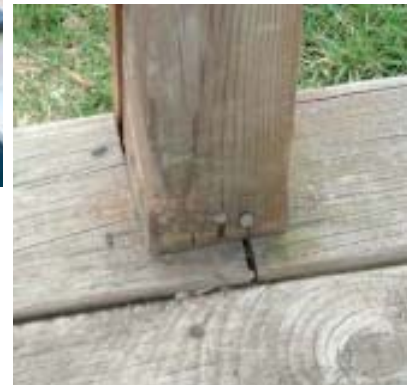
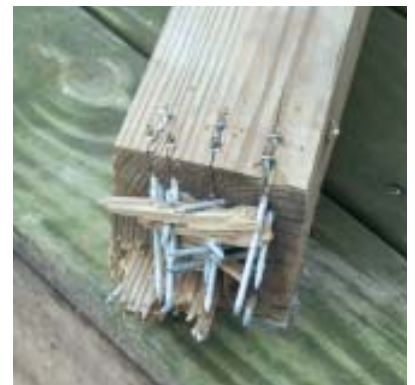
Researchers at Virginia Tech applied measured loads to deck posts to see which connections could meet code. The tests were spawned in part by one author's observations of dangerously weak details on existing decks, as in the two examples below, where railing posts were simply toenailed into the decking. The post in the bottom photo was covered by a decorative plastic cover, which concealed the flimsy connection.

The point was brought home to us when Frank was asked to inspect the railing on a friend's deck and found the rail posts toenailed into the decking (see photos on previous page), an unacceptably flimsy connection. Looking around our area of Virginia, we spotted other railing connections that made it clear that some deck builders, at least, aren't aware of code requirements for deck railings.

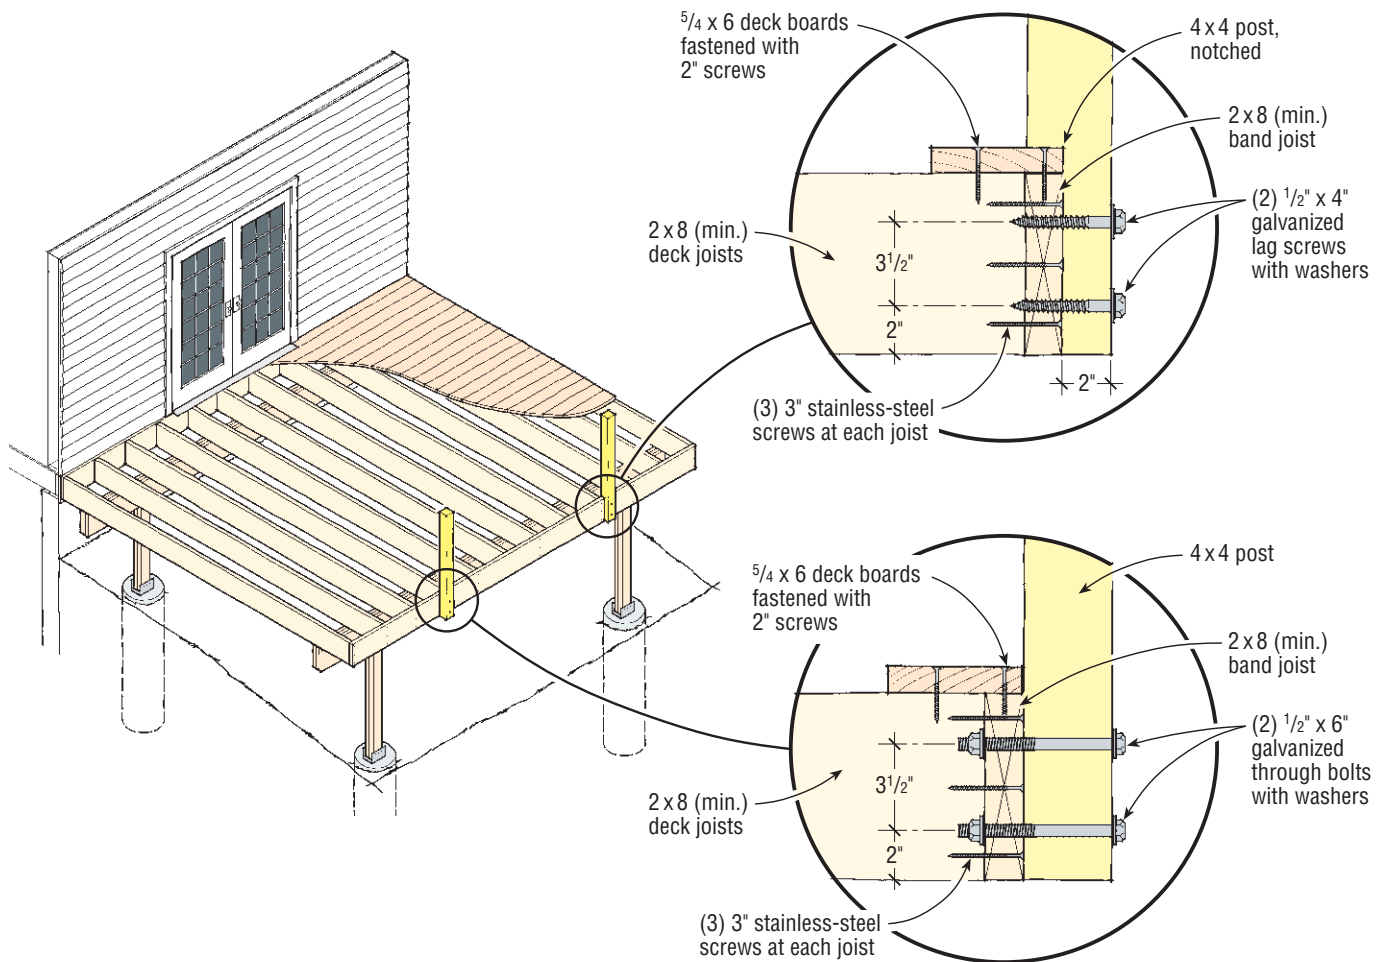
Figure 1. The authors first tested two post connections found commonly in their area, one where the 4x4 pressure-treated post is notched and lag-screwed to the band joist (top detail), and a second where the post is through-bolted to the deck band joist (bottom detail). Code requires that a rail post be able to withstand a 200-pound force applied in any direction. The researchers tested the worst-case scenario only, by pulling outward at the top of the post; they applied a 2.5-times safety factor, according to code-accepted test protocol.

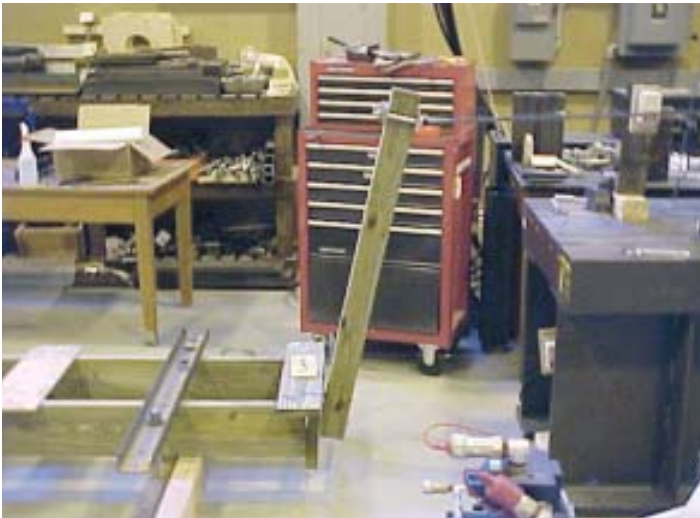
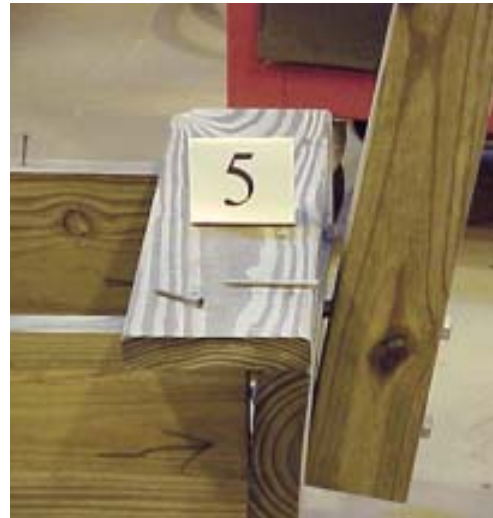
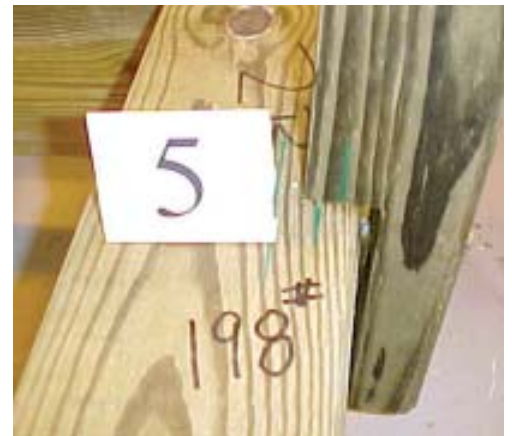
Figure 2. Although the bolted and lagged connections appeared sturdy, neither type could come close to meeting the target 500-pound test load, as the table shows. The authors tested five samples of each connection, applying a horizontal force at the top of the post until the post detached from the joist structure or the band joist itself came off. A piece of 5/4 decking nailed to the simulated joists and band joist did little to prevent failure.

The lag-screwed connection failed at less than 200 pounds when the lags pulled out of the band joist. The bolted connections failed at an average load of 237 pounds — barely surpassing the code design load but with almost no safety factor for the service life of the deck. The bolted samples typically failed when the band joist peeled away from the deck joists, as the screws attaching the band to the joists pulled out. The screws holding the 5/4 deck

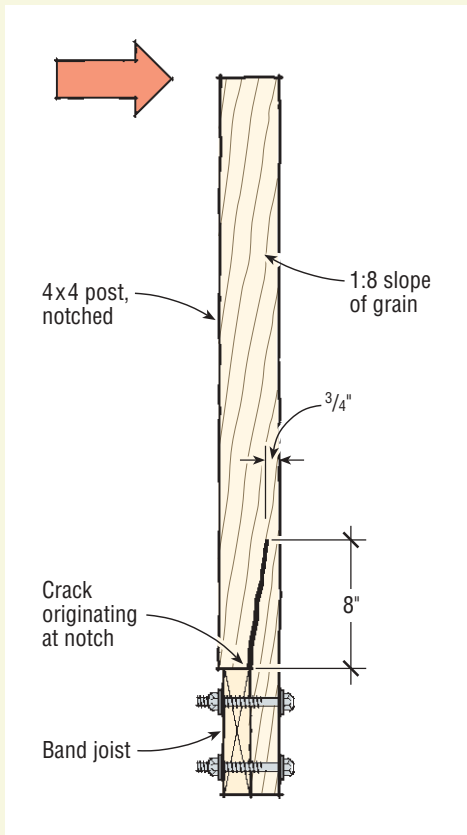
Why Not Notch?

Cracks will typically develop from the corner of a notch (photo, right). As a crack develops, a steep “slope of grain” can critically reduce the section of the post, as the drawing shows.

Many years of observation have proved that moisture cycles will typically cause cracks to develop and propagate, parallel to the grain, from the corner of the notch. This may not be apparent when the post is first installed, but it happens gradually over time.

According to the grading rules for lumber, a piece of 4x4 No. 2 southern pine can have a “slope of grain” of up to 1:8 (or 1 inch in 8 inches). If a 4x4 with a slope of grain of 1:8 is notched 1.75 inches deep, a crack propagated along the grain will reduce the 1.75-inch-thick section at the notch to only $\frac{3}{4}$ inch at 8 inches above the corner of the notch — not something you’d want to bet your life on.

Several of the 4x4 posts we tested were notched around the band joist — a common detail in the field. While you might expect the notch to be the weak point in the connection, in fact none of the test posts failed at the notch. Even so, notching should be avoided, because it does substantially reduce the strength of the post. Here’s why:

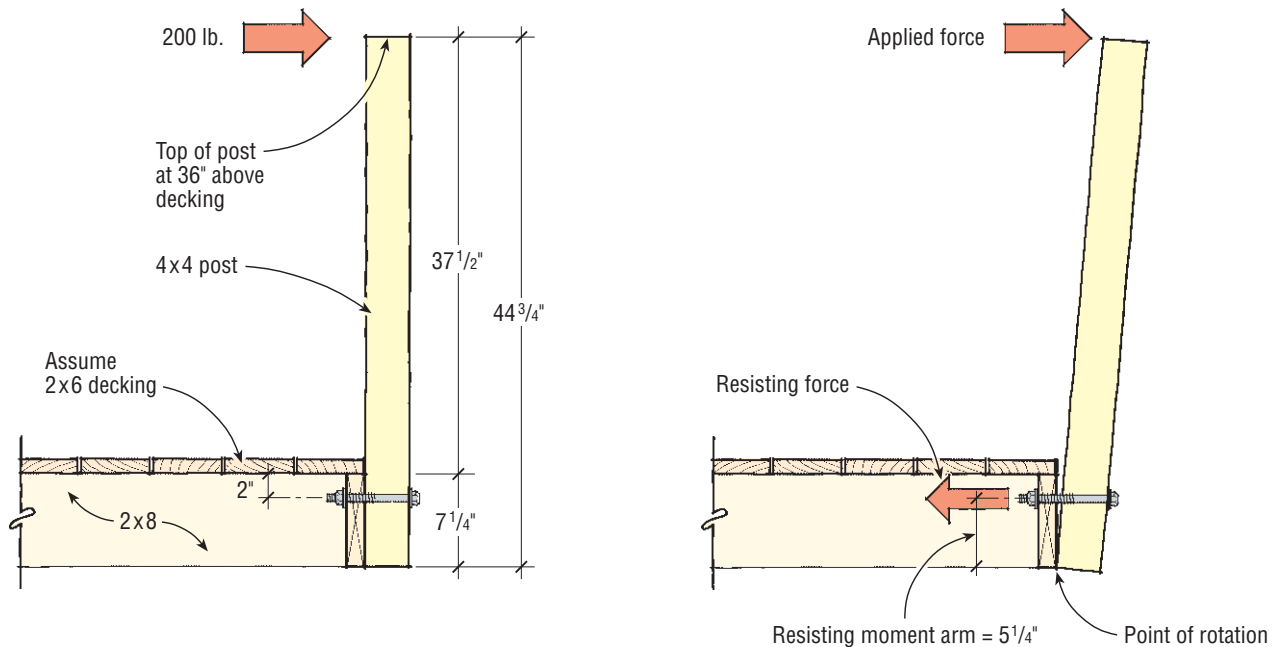
Forces in a Typical Guardrail Post

Applied moment = 200 lb. x 44.75 in.
= 8,950 inch-pounds at base of post

Resisting force = 8,950 inch-pounds / 5.25 in.
= 1,705 lb.

A guardrail post can behave like a lever: The force applied at the top gets multiplied by the length of the post — the lever arm — to produce a large moment, expressed in inch-pounds, at the base. The resisting force at the base, here represented by a single bolt, is also multiplied, but by a much shorter lever arm — 5 1/4 inches in this example. In the case shown here, representing a typical residential deck rail post 36 inches high, the bolt would have to provide nearly 2,000 pounds of resisting force. While the steel itself might be up to the task, the wood fibers under the washers would not be strong enough, as the authors' tests indicated.

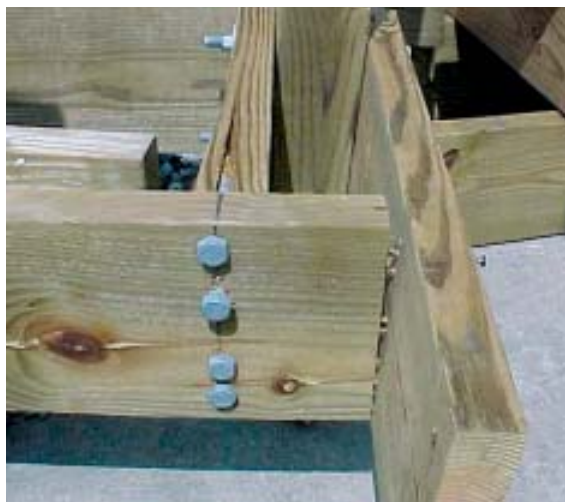
Figure 3. After testing the bolted and lagged connections, the authors tried reinforcing the post with blocking in a variety of configurations. Each configuration they tried failed when the blocking split along the grain.

Once it was clear these two common details were inadequate, we tried various ways of blocking around the post, attempting to distribute the load over many lag screws to reach the 500-pound test load. These attempts typically failed when the lumber split under perpendicular-to-grain loading — the kind of load exerted when you split wood with an axe (Figure 3, previous page).

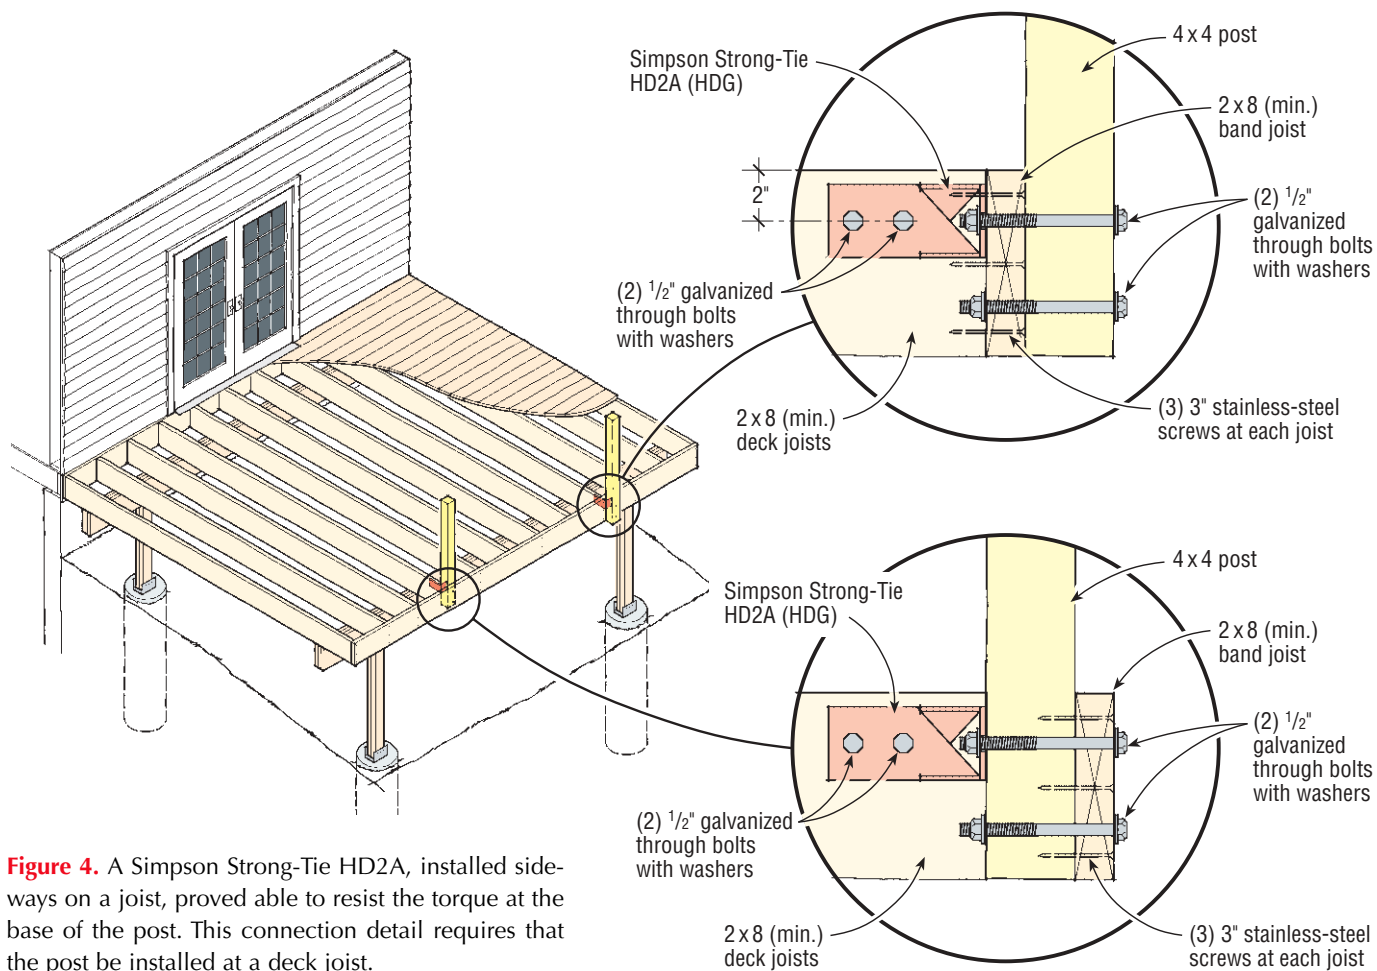
Figure 4. A Simpson Strong-Tie HD2A, installed sideways on a joist, proved able to resist the torque at the base of the post. This connection detail requires that the post be installed at a deck joist.

We turned to a commercial steel connector — a Simpson Strong-Tie HD2A — which is designed to resist wind and earthquake loads in shear walls. By orienting the connector sideways along the joist, we were able to use it to secure the post (Figure 4). We installed the HD2A with three 1/2-inch-diameter bolts: The two bolts in the third joint, passing through the post, the band, and the connector itself, is loaded in tension. As part of the tested design, we also installed another 1/2-

We used only one Simpson HD2A per post, placing the centerline of the connector 2 inches below the top edge of the 2x8 joist. If you use this detail in the field, it's important to maintain this centerline distance, because it helps to limit the forces involved in the connection. If you place the HD2A lower, you're reducing the resisting lever arm, which extends from the bottom of the band joist to the centerline of the connector. Losing even an inch of this resisting lever arm would greatly increase the forces in the connector.

We used a hot-dipped galvanized (HDG) HD2A connector for our tests. Because of the corrosive nature of the new lumber treatments, this is the version that should be used in practice.

The 1/2-inch bolts, washers, and nuts should also be hot-dipped galvanized.

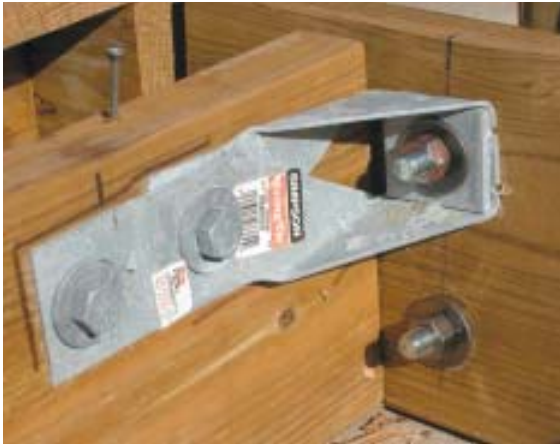
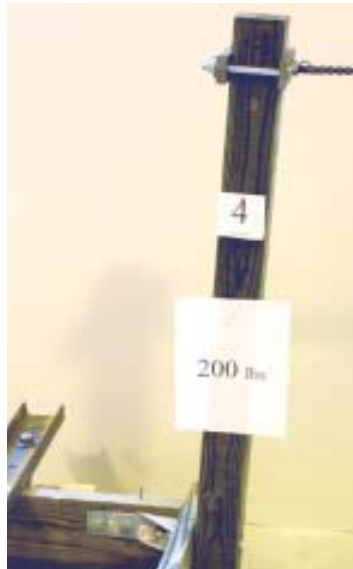
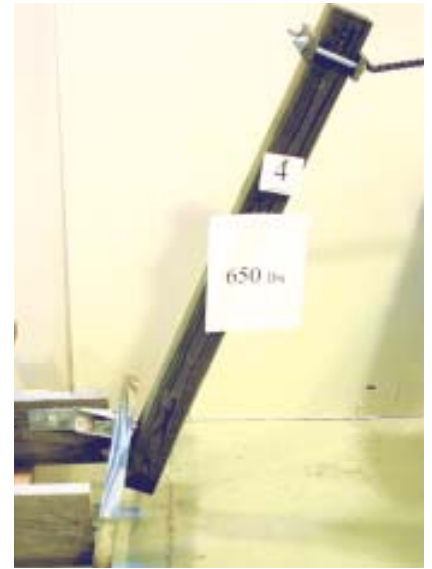
When the post was mounted inside the band, the washers under the bolt head embedded into the wide face of the 2x8 band joist. When the post was located outside the band, the bolt head and washer pulled well into the 4x4 post, crushing the wood fibers beneath the washer.

Figure 5. The authors tested the HD2A connection with the post installed both inside and outside the band joist; both configurations withstood the full test load. At 200 pounds, the sample post shown above deflected but the connection held; at 650 pounds, with the post still holding, the test was ended so as not to damage the test machine.
